NATIONAL PROGRAM FOR INSPECTION OF NON-FEDERAL DAMS
GOODWIN DAM (CT 00541 (U) CORPS OF ENGINEERS WALTHAM
MA NEW ENGLAND DIV SEP 78

FARMINGTON, CONNECTICUT

GOODWIN DAM CT. 06541

PHASE I INSPECTION REPORT DAM INSPECTION PROGRAM

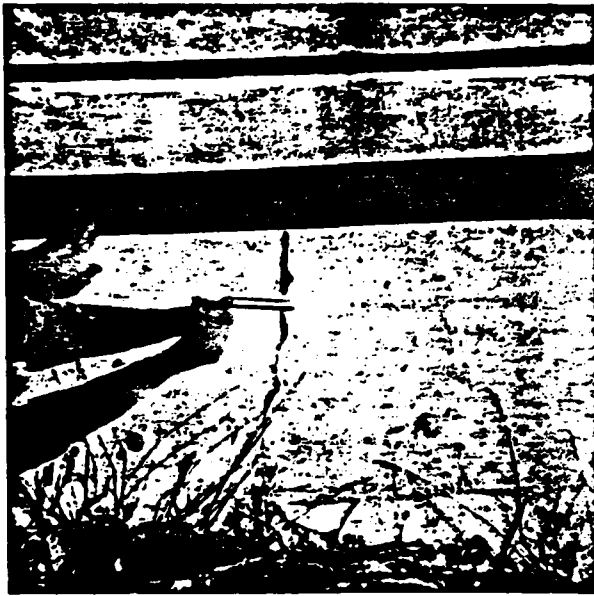
#11. South face at West end. Finger points to location of rollers.

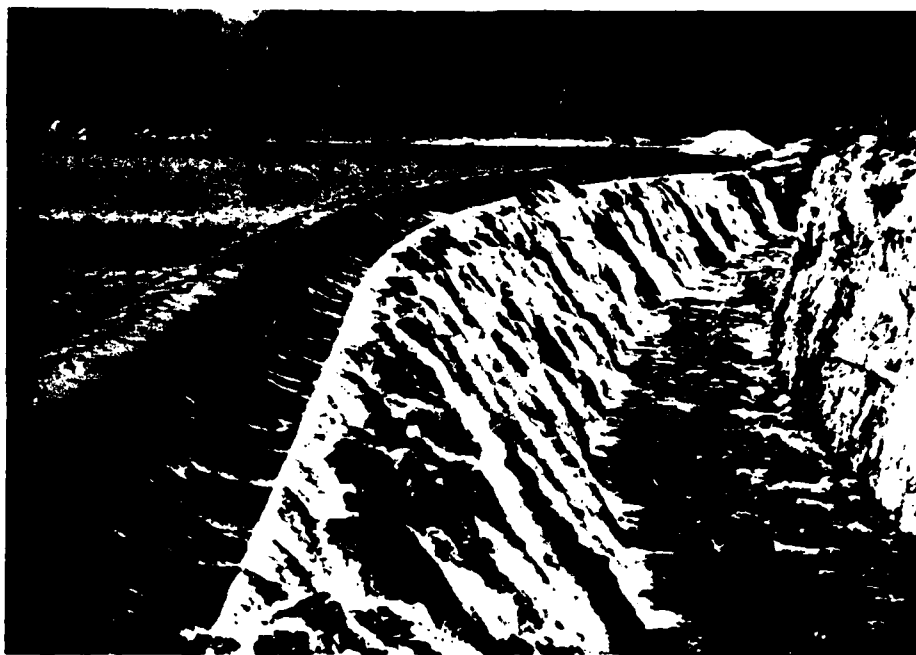
c. Appurtenant Structures - The spillway is a concrete weir on top of a ledge channel (Appendix C, Page II-2) and is in good condition. The spillway channel condition is excellent and there are no evidences of loose rock or slippage of any ledge.

PHOTO 3
SPILLWAY WEIR
